**Flood Control Project Maintenance
Levee Inspections**

Fall 2015 Levee Maintenance Deficiency Summary Report

San Joaquin River Basin

Reclamation District No. 2094 Wathal

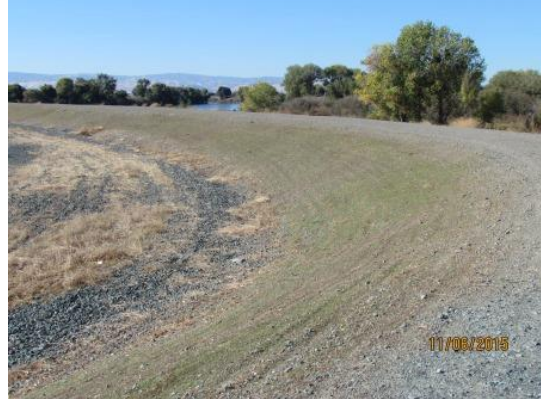
Photo 1 of 1 : FA_2015_RD2094_320_6_20151112_00005.jpg

LM Start	0.08	Rating **	A	Issue No.	6
LM End	2.78	Issue Type +	Ma	Location *	LS
Category	Earthen Levee			GPS Latitude/Longitude	
				Start	End
Item	Vegetation			37.771687 °	37.749548 °
				-121.299846 °	-121.288919 °
DWR ID	DWR_RD2094_01_f_2015_6				
Action/Comments					
Control annual grass and weeds on the levee slopes and easements.

View of the acceptable vegetation control on the landside levee slope.

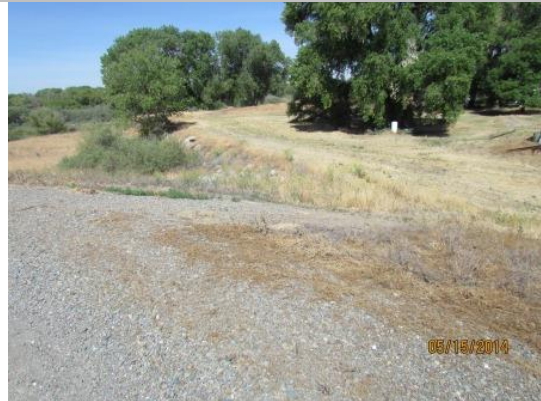
Photo 1 of 1 : FA_2015_RD2094_320_4_20150910_00001.jpg

LM Start	0.10	Rating **	M	Issue No.	4
LM End	0.10	Issue Type +	En	Location *	WS
Category	Earthen Levee			GPS Latitude/Longitude	
				Start	End
Item	Encroachments			37.771685 °	37.771685 °
				-121.300239 °	-121.300239 °
DWR ID	DWR_RD2094_01_s_2012_4				
Action/Comments					
Ramp					
Inspector Comments: An access ramp has been built on the water side and extends into the channel. This could potentially alter the channel capacity. This item was also noted in the USACE comments.

Tire marks shown onto the ramp from levee. Raised area extends to the trees in the background in the center of the photo.

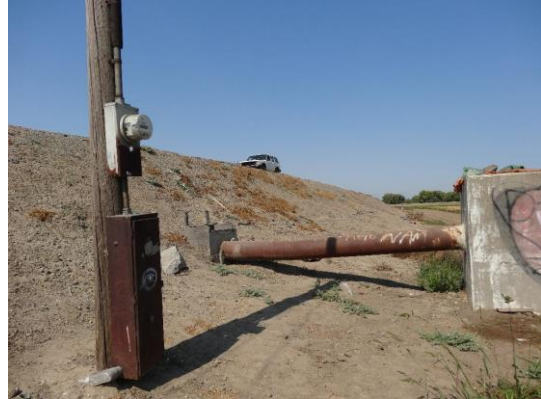
Photo 1 of 3 : UCIP_FA_2015_2330.jpg

Inspector Comments: FS_ID:21464
 DS_ID:23086
 EP_NO: N/A
 FS_HLM: 0.66
 Repair Type: Non-Urgent
 Crossing Status: Found
 UCIP Comments: - walkway in poor condition and needs repair.-
 electric conduit on waterside.
 FIELD_STRUCT_DESC: 14-inch concrete encased steel pipe and GI
 conduit through the levee, 10.0 feet below the crown, pump mounted on
 a pile structure in the stream, slide gate, 54-inch corrugated metal pipe
 riser on the waterward shoulder, concrete distribution box and service
 pole on the landward toe, installed by USCE, 1962 (O&M Unit No. 3,
 1968)
 FS Date: 09/10/2013

LS view: exposed pipe, service pole, and concrete distribution box on levee toe.

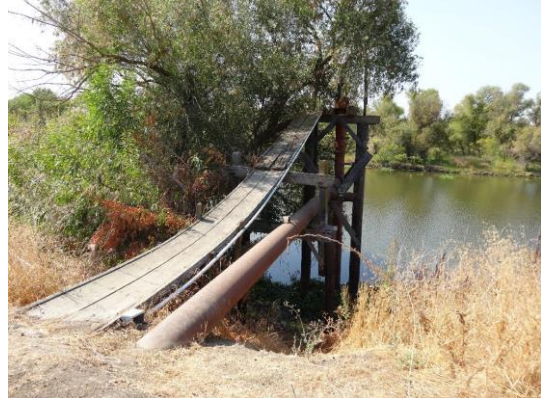
Photo 2 of 3 : UCIP_FA_2015_2331.jpg

WS view: pump on piling structure in the channel. Pipe (right- bottom) and conduit (bottom- left).

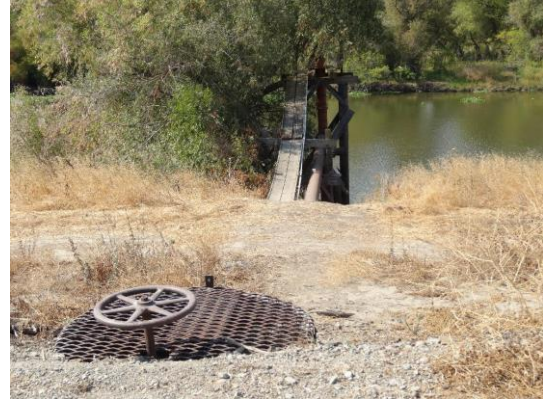
Photo 3 of 3 : UCIP_FA_2015_2332.jpg

WS view: gate valve in CMP riser (bottom) and pipe & pump (top) on piling structure in the channel.

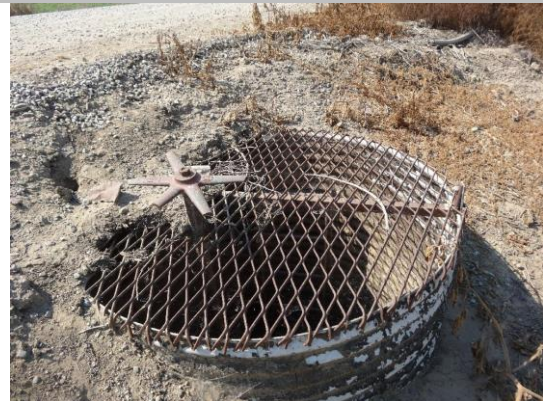
Photo 1 of 3 : UCIP_FA_2015_1793.jpg

LM Start	1.25	Rating **	M	Issue No.	14
LM End	1.25	Issue Type +	En	Location *	WS
Category	Supplemental			GPS Latitude/Longitude	
				Start	End
Item	DWR UCIP Field Study		37.760581 °	37.760581 °	
			-121.297373 °	-121.297373 °	
DWR ID					
Action/Comments					
Inspector Comments: FS_ID:21544 DS_ID:23087 EP_NO: N/A FS_HLM: 1.265 Repair Type: Non-Urgent Crossing Status: Found UCIP Comments: - working as drainage system during field visit. Pump was not running.- electric conduit on WS- open pipe end in CMP riser. CMP needs cleaning. FIELD_STRUCT_DESC: 20-inch concrete encased steel pipe through the levee, 10.0 feet below the crown, pump mounted on a pile structure in the stream, gate valve, 54-inch corrugated metal pipe riser on the waterward shoulder, concrete distribution box and service pole on the landward toe (O&M Unit No. 3, 1968) FS Date: 09/10/2013

WS view: damaged gate valve handle in CMP riser on levee shoulder.

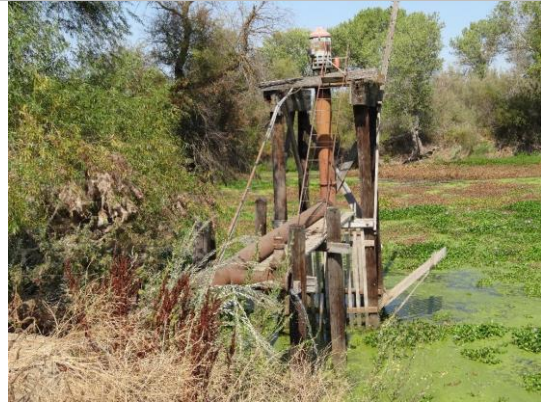
Photo 2 of 3 : UCIP_FA_2015_1794.jpg

Inspector Comments: FS_ID:21544
 DS_ID:23087
 EP_NO: N/A
 FS_HLM: 1.265
 Repair Type: Non-Urgent
 Crossing Status: Found
 UCIP Comments: - working as drainage system during field visit. Pump was not running.- electric conduit on WS- open pipe end in CMP riser. CMP needs cleaning.
 FIELD_STRUCT_DESC: 20-inch concrete encased steel pipe through the levee, 10.0 feet below the crown, pump mounted on a pile structure in the stream, gate valve, 54-inch corrugated metal pipe riser on the waterward shoulder, concrete distribution box and service pole on the landward toe (O&M Unit No. 3, 1968)
 FS Date: 09/10/2013

WS view: pipe and pump on piling structure in the channel. Walkway in poor condition.

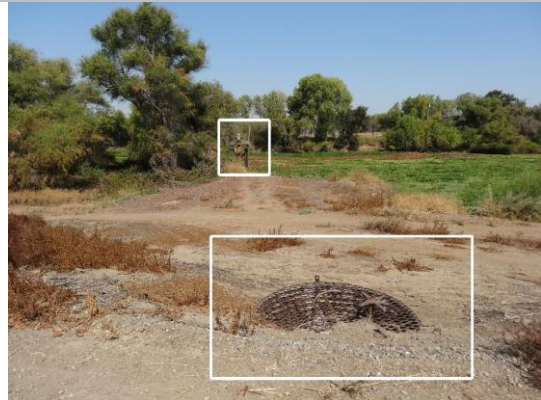
Photo 3 of 3 : UCIP_FA_2015_1795.jpg

WS view: overview of pump (top) and CMP riser (bottom)

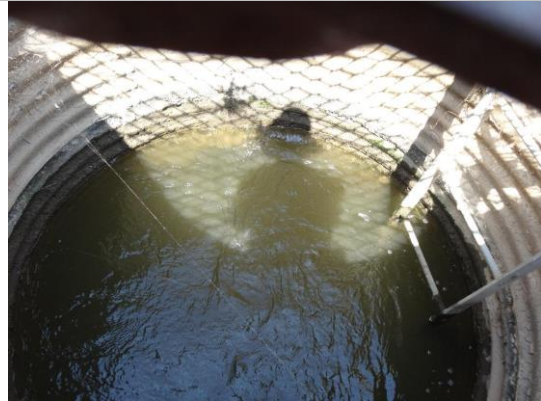
Photo 1 of 3 : UCIP_FA_2015_2278.jpg

LM Start	2.25	Rating **	M	Issue No.	15
LM End	2.25	Issue Type +	En	Location *	WS
Category	Supplemental			GPS Latitude/Longitude	
				Start	End
Item	DWR UCIP Field Study			37.752230 °	37.752230 °
				-121.296408 °	-121.296408 °
DWR ID					
Action/Comments					
Inspector Comments: FS_ID:41726					
DS_ID:23088					
EP_NO: N/A					
FS_HLM: 2.286					
Repair Type: Non-Urgent					
Crossing Status: Found

WS view: inside view of CMP riser on levee shoulder. No slide gate found.

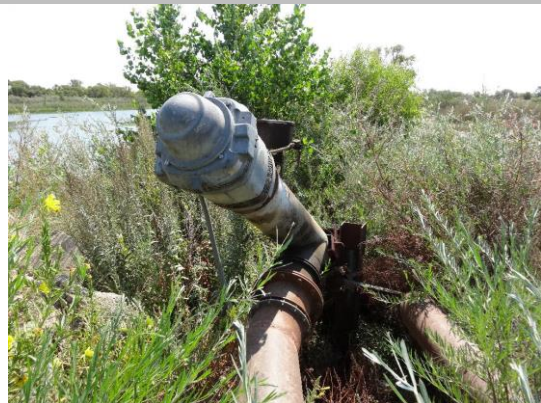
Photo 2 of 3 : UCIP_FA_2015_2279.jpg

WS view: slant pump on stream bank and dense vegetation on stream bank.

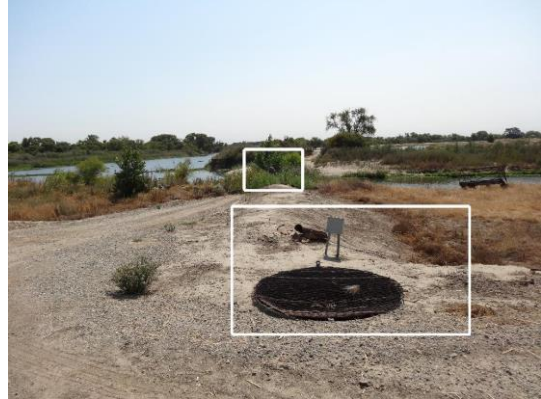
Photo 3 of 3 : UCIP_FA_2015_2280.jpg

WS view: slant pump (top) on stream bank and CMP riser on levee shoulder.

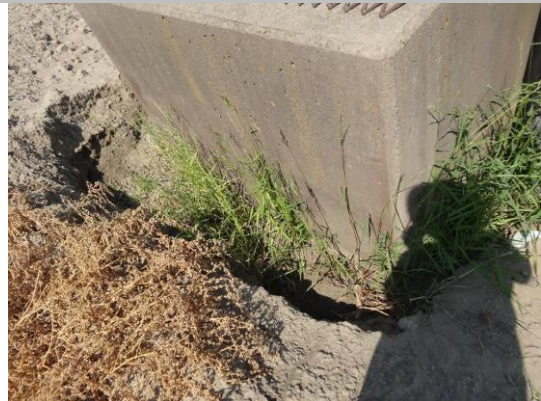
Photo 1 of 3 : UCIP_FA_2015_1796.jpg

LM Start	2.45	Rating **	M	Issue No.	16
LM End	2.45	Issue Type +	En	Location *	WS
Category	Supplemental			GPS Latitude/Longitude	
				Start	End
Item	DWR UCIP Field Study			37.752308 °	37.752308 °
				-121.293191 °	-121.293191 °
DWR ID					
Action/Comments					
Inspector Comments: FS_ID:21545 DS_ID:23089 EP_NO: N/A FS_HLM: 2.488 Repair Type: Non-Urgent Crossing Status: Found UCIP Comments: - no pipes found on either side of the levee.- concrete distribution box on LS. Soil erosion around distrinution box. FIELD_STRUCT_DESC: Rectangular concrete distribution box on the landward toe FS Date: 09/10/2013

LS view: erosion around a concrete standpipe on the landside toe.

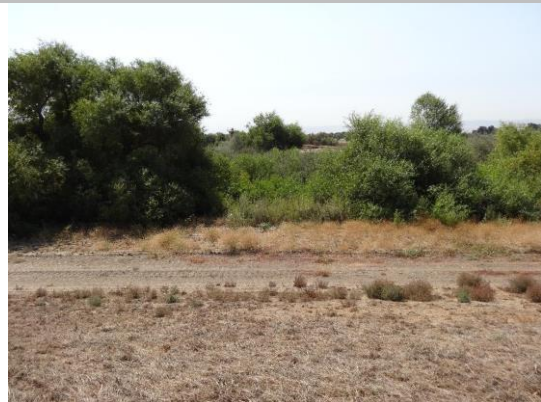
Photo 3 of 3 : UCIP_FA_2015_1798.jpg

WS view: no pipe found on waterside.

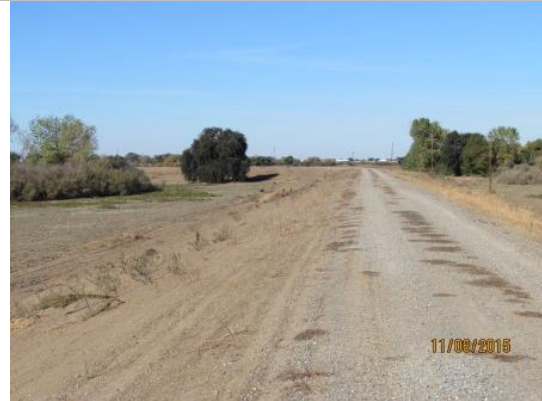
Photo 1 of 1 : FA_2015_RD2094_321_1_20151112_00001.jpg

LM Start	0.02	Rating **	A	Issue No.	1
LM End	0.43	Issue Type +	Ma	Location *	WS
Category	Earthen Levee			GPS Latitude/Longitude	
				Start	End
Item	Vegetation			37.759324 °	37.760603 °
				-121.299892 °	-121.306912 °
DWR ID	DWR_RD2094_02_f _ 2015_1				
Action/Comments					
Control annual grass and weeds on the levee slopes and easements.

View of the acceptable vegetation control on the waterside levee slope.
